# Castillo de San Severino

Museo de la Ruta del Esclavo  
*Slave Route Museum*

GUIA DE VISITANTE | VISITOR'S GUIDE

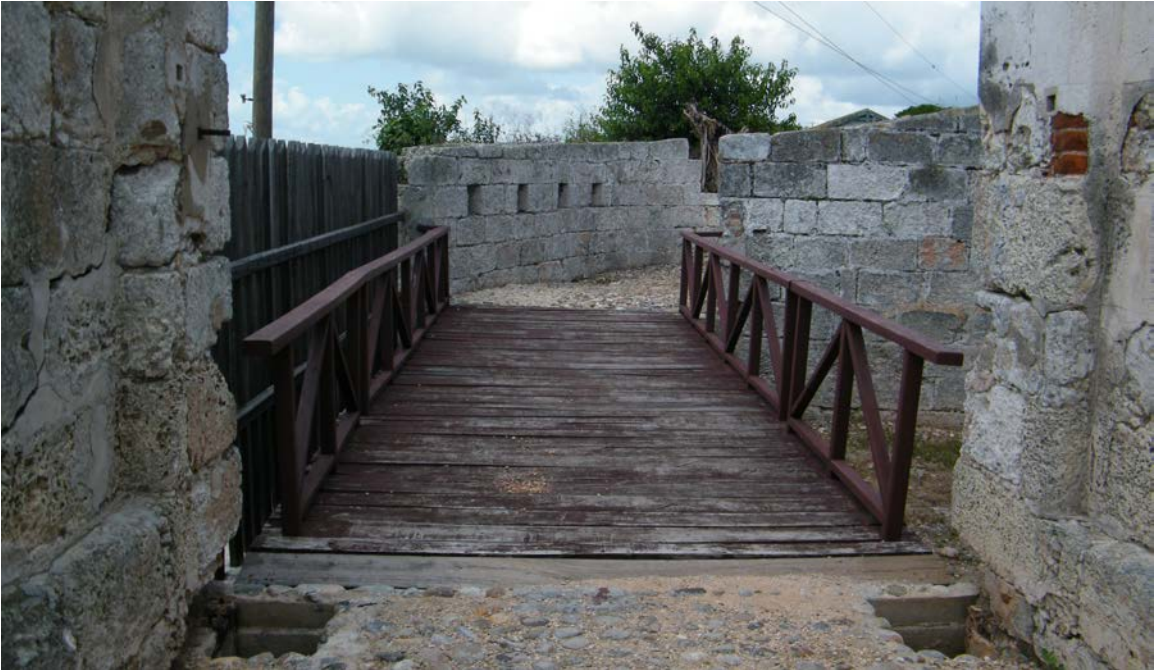
### 3 EL PUENTE LEVADIZO

Los puentes constituyeron obras fundamentales en las fortificaciones. Su función no era sólo conectar diferentes espacios construidos para la defensa que estaban separados por el foso, sino también crear obstáculos en caso de necesidad. Estos pueden ser levadizos, estables, fijos o durmientes y giratorios. San Severino cuenta con dos puentes, uno que era levadizo y otro fijo o durmiente. El puente levadizo comunica el camino serpenteado que le sigue a la puerta principal de la fortaleza con la Plataforma de San Juan, su obra de avanzada. Se construía de forma mixta, con una parte fija con una base de pilares de madera, ladrillos o mampostería, y la otra parte levadiza, con un tablero de madera del ancho de la puerta que la cerraba cuando se elevaba. El puente debía suspenderse con un mecanismo de cadenas o masas cilíndricas de hierro. Al levantarse este puente se cerraba el acceso al parapeto aspillero de la plataforma, aislando la fortaleza a través del foso. Hoy en día el mecanismo que lo elevaba ha desaparecido. Durante los trabajos de restauración que se realizaron en el año 2006 se logró recuperar parte de uno de los dispositivos que lo suspendía. Los pilares de madera de este puente fueron sustituidos por sillares en 1851. Tras años de abandono, el puente desapareció, pero fue nuevamente erigido en las labores de restauración del 2008, aunque esta vez como puente fijo.

The bridges were fundamental features of fortifications. Their function was not only to connect different spaces built for defense that were separated by the moat, but also to create obstacles in case it was necessary. They can be classified as drawbridges, movable, immovable or dormant, swing bridges, etc. San Severino had two: one drawbridge and one immovable or dormant bridge. The drawbridge communicated the access way that follows the main gate of the fortress with San Juan's Platform, the forts' advanced defense. It was built with a fixed part, which had a base of wooden pillars, bricks or masonry. The movable part, consisted of a wooden board the same size of the door that closed when it was raised. The bridge was to be suspended with a chain mechanism or cylindrical iron counterweights. When the bridge was lifted, the access to the platform's parapet was closed, thus the moat isolated the fortress. Today the elevating mechanism has disappeared. During the restoration carried out in 2006, it was possible to recover part of the lifting drums that were used to draw the bridge up. Masonry pillars replaced the wooden pillars of the bridge in 1851. After years of abandonment the bridge disappeared, but was again erected during the restoration in 2008, although as a dormant bridge this time.

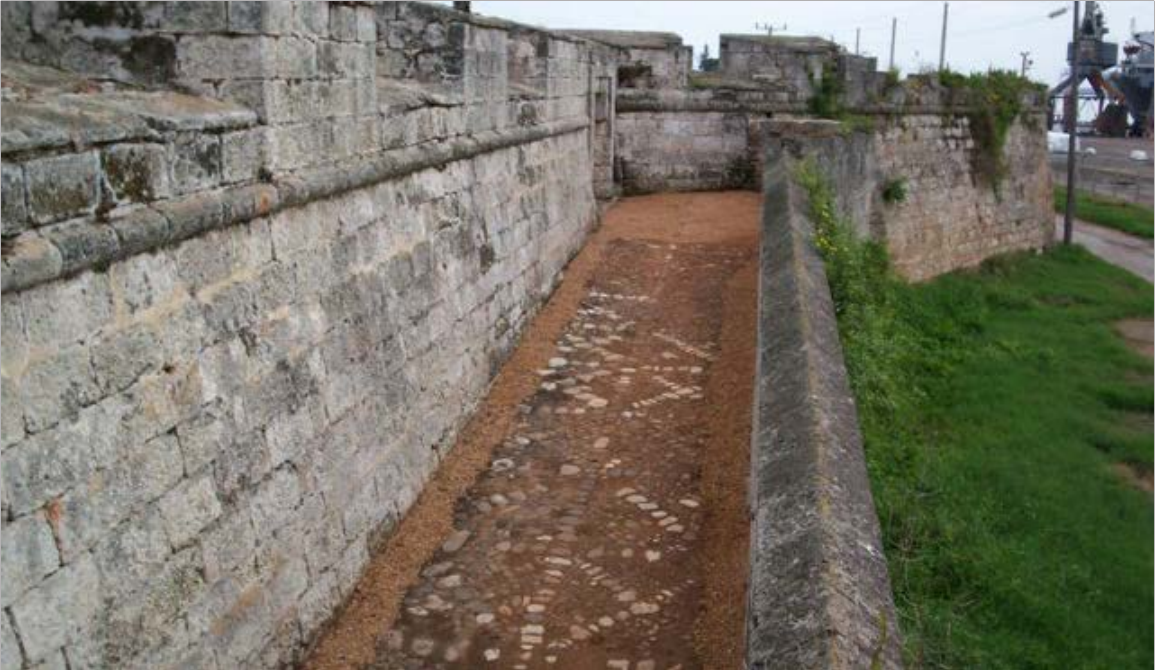
## 4 EL CAMINO CUBIERTO Y SUS GUIJARROS

El camino cubierto, también denominado entrada encubierta, era un camino terraplenado protegido por el parapeto. Forma parte de la defensa marítima de la fortaleza y comunica el puente levadizo con la puerta de acceso a la Plataforma de San Juan. El muro que da a la bahía posee varias aspilleras para la defensa con fusil en caso de ataque. Durante su restauración en el año 2006 se descubrió el piso original del camino. Se pudo determinar que estaba compuesto por una diseñada organización de guijarros o chinias pelonas, que adornan el transitar al interior de la fortaleza. Luego de la voladura del castillo en 1762, se plantearon varias modificaciones para el camino cubierto, aunque entre 1777 y 1781 aún no se habían completado. Algunos cambios adicionales también se plantearon, como aumentar su profundidad, lo cual aparentemente nunca se llevó a cabo. Este constituye la entrada principal al Castillo, por lo que parece haber sido elegido para colocar la tarja fundacional y uno de los escudos que tuvo el inmueble. Si bien no se conoce del paradero de estas importantes piezas, la detallada observación de los muros permitió ubicar dos espacios cavados en los sillares del muro al final del camino cubierto, donde se abre una pequeña plaza. Ambos lugares parecen coincidir con la tarja y el escudo desaparecidos. Hoy se pueden apreciar estos espacios que otrora sostuvieron dos de los emblemas de San Severino.

The covered way, also called the covert entrance, was a terraced path protected by a parapet. It is part of the maritime defense of the fortress and communicates the drawbridge with access door to San Juan's Platform. The seawall of the way has several loopholes for rifle defense in case of attack. The original floor was recovered during its restoration in 2006. It consists of an organized pattern of cobblestones which adorn the way to the interior of the fortress. After the damage inflicted by the explosion in 1762, several modifications were proposed for the covered way, although between 1777 and 1781 they had not yet been completed. Some additional changes were also suggested, such as increasing its depths, which apparently never happened. The covered way constituted the main entrance to the Castillo, so it seems to have been chosen as the place to house the foundational plaque and one of the fort's coat of arms. Although these important pieces are lost today; detailed observation of its walls allowed the location of two spaces carved at the end of the covered way, where a small plaza opens up. These two spaces seem to match the missing plaque and coat of arms. Today we can see the spaces where these two fort emblems were originally placed.

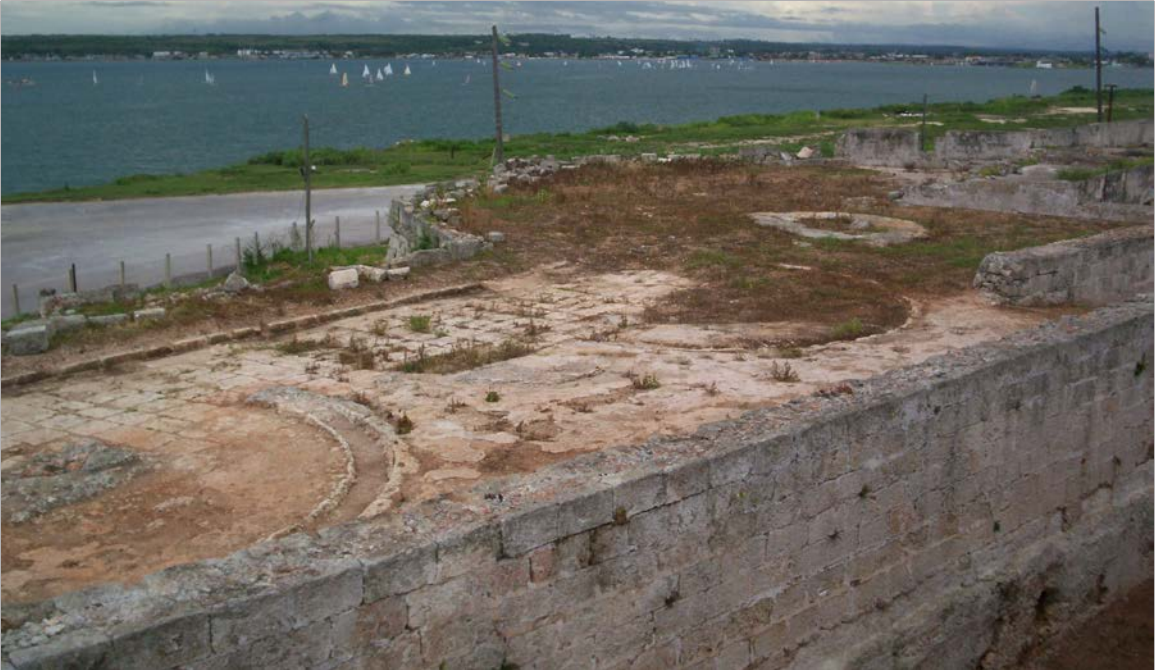
## 5 COLISAS PARA CAÑONES EN LA PLATAFORMA DE SAN JUAN

En la década de 1880 se proyecta la renovación de la artillería del Castillo de San Severino, que ya estaba obsoleta para entonces. Los nuevos cañones, del denominado Sistema Elorza, tenían mayor alcance y rendimiento, a la vez que permitía una movilidad más dinámica. Eran montados sobre cureñas de madera con ruedas de metal que giraban sobre las colisas en forma de arco. En San Severino fueron instaladas al menos una en el Baluarte de San Antonio y tres en la Plataforma de San Juan. La artillería nueva aparece en un par de planos, pero un hallazgo interesante fue encontrar una foto del siglo XIX, donde aparecen cuatro cureñas de madera con ruedas en la Plataforma de San Juan. Pero además, cuando los arqueólogos monitoreaban los trabajos de limpieza en la fortaleza, se localizaron dos de las colisas mencionadas, excavadas en un piso de sillares que era desconocido hasta ese momento. Otra estructura semicircular también fue descubierta, probablemente para una tercera pieza de artillería. Un detalle importante es que para la instalación, tuvieron que hacer grandes modificaciones a la Plataforma, lo que incluyó demoler parte de la muralla con las antiguas troneras y las banquetas, utilizadas para que la tropa pudiera ver por sobre el parapeto. A pesar de no contar con esas extraordinarias piezas de madera en la actualidad, nos quedan las huellas de las colisas, labradas en la roca.

The artillery of Castillo San Severino was already obsolete by the 1880's when a new renovation was projected. Cannons of the Elorza system were installed. They had a greater reach and performance, and at the same time allowed a more dynamic mobility. The iron cannons were mounted over wooden carriages with metal wheels, mounted on wood carriers, which moved over arched roller paths. At least one was installed at San Antonio's bastion and four in the San Juan's Platform. These new artillery pieces appear indicated in a couple of plans. We have located an XIX Century photograph where four of the wooden carriages with wheels appear on the San Juan's Platform. When archaeologists were monitoring the works carried out in the platform, two of the aforementioned roller paths were located carved onto the floor, exposing them for the first time in decades. A third semicircular structure was also discovered, probably related to a third artillery placement. An important detail is that to install all these artillery pieces, major modifications were carried out which included demolishing part of the wall embrasures and firing steps so that the troop could see over the parapet. Despite not having these extraordinary wooden carriages today, the roller paths have been preserved carved on the rock floor.

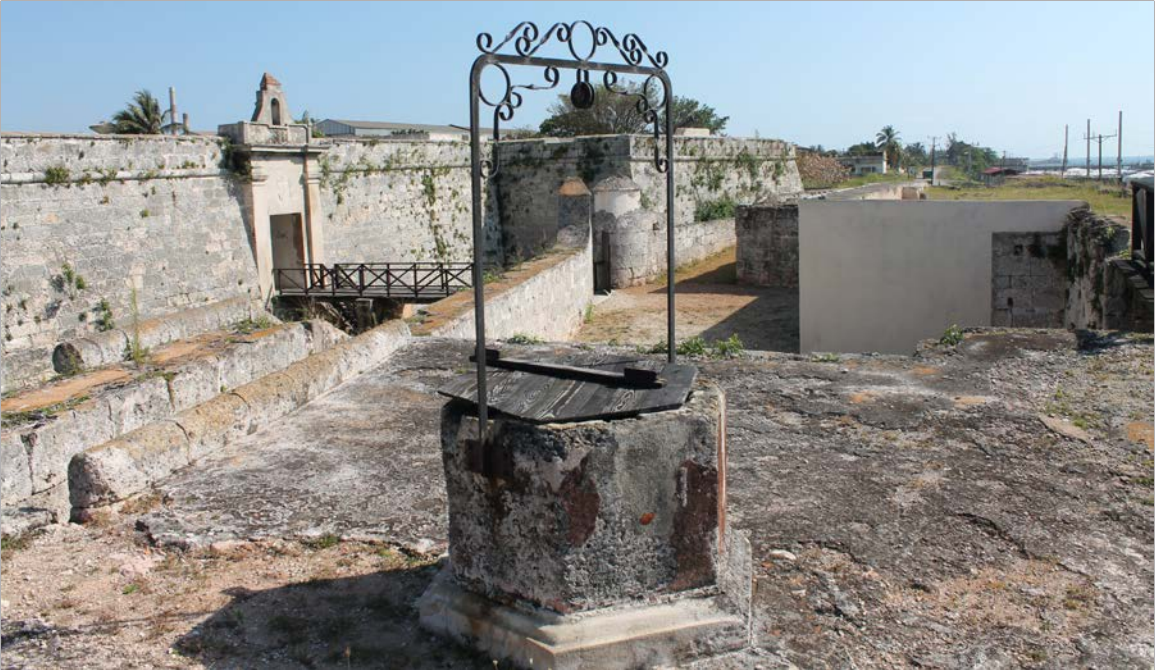
## 6 LOS ALJIBES Y EL ALMACENAMIENTO DE AGUA

Uno de los aspectos fundamentales de las fortificaciones fue el abasto de agua para la dotación. Para ello se utilizaron los aljibes, que recolectaban el agua de lluvia. Estas fueron una de las primeras obras constructivas del Castillo, iniciadas poco después de su planeamiento, entre 1689 y 1693. Era vital para el personal que allí vivía y trabajaba día a día en su construcción, tener un abastecimiento de agua potable. Durante los planes la reedificación del inmueble entre 1768 y 1772, se hablaba del mal estado de los tres aljibes con que contaba la fortaleza. Las cartas de los contratistas, constructores, arquitectos y el gobernador de la isla mencionan la recomposición de los aljibes, en especial el fondo, las paredes y sus bombas, que fueron dañadas en la explosión del verano de 1762. Los aljibes o cisternas fueron primeramente revisados en 1768 y finalmente recompuestas en 1781, con un costo total aproximado de 390 pesos. En 1777 uno de los aljibes se reventó, posiblemente durante las labores reconstructivas. Con el paso del tiempo y la instalación del agua corriente, estos espacios quedaron en abandono. En 1998, mientras se realizaban trabajos arqueológicos en la fortaleza, un grupo de investigadores descendieron en cuerdas al aljibe que se encuentra a un lado de la Casa del Gobernador, donde fueron hallados cantidades de documentos históricos olvidados desde la década de 1940.

One of the main aspects of any fortification is the water supply for the troops. To this end, cisterns were used to collect rainwater. These were one of the first features built in the fort shortly after its planning between 1689 and 1693. It was vital for the troop and the people that worked day by day on its construction to have a supply of drinking water. During the reconstruction of the fort between 1768 and 1772, the three cisterns were in a very poor state. Contractors, builders, architects and even the island Governor wrote letters mentioning the necessary repairs of the cisterns, especially its floors, walls and vaults that were damaged during the explosion in 1762. The cisterns were first revised in 1768 and finally rebuilt in 1781 with a total cost of about 390 pesos. In 1777 one of the cisterns burst possibly during its reconstruction. With the installation of running water on the fort the cistern system became obsolete. In 1998, while conducting archaeological work in the fortress, archaeologists descended into the cistern located next to the Governor's House where they found many historical documents that were deposited there in to the 1940's.

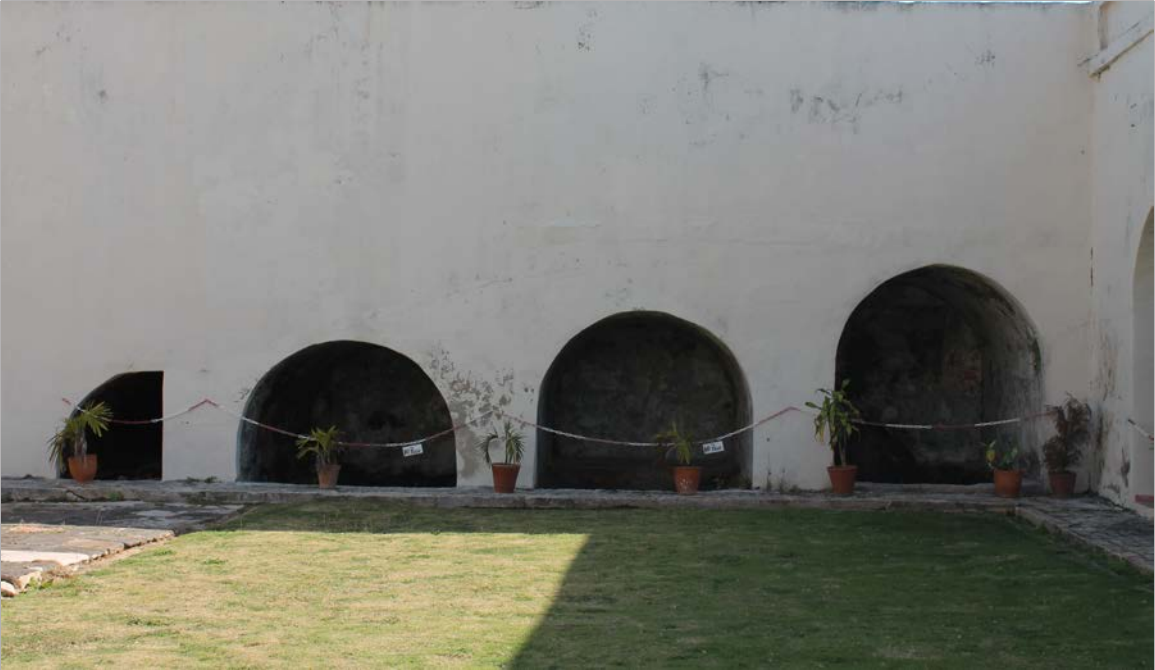
## 10 LAS BOVEDILLAS BAJO LA RAMPA DE ALMACÉN A LETRINA

Las bovedillas debajo de la rampa fueron construidas alrededor de 1731 y 1746. Estas sirvieron originalmente de despensa, panadería y cocina hasta la voladura del Castillo el 26 de agosto de 1762. Durante su reconstrucción, entre 1768 y 1778, vuelven a ejercer como almacenes, convirtiéndose durante ese momento en basurreo y letrina. Las letrinas no sólo fueron los baños de la fortaleza. Era costumbre por entonces usarlo como lugar de descarte, por lo que son lugares muy ricos en evidencias del pasado. En estas bóvedas se han realizado diversas excavaciones arqueológicas que han permitido rescatar el mayor cúmulo de materiales arqueológicos hasta el momento. Estos artefactos, muchos de ellos en exhibición en las salas de este museo, revelan interesantes aspectos de la vida cotidiana de presos y soldados desde finales del siglo XVIII hasta finales del XIX. Es a través de ellos que sabemos lo que comían, los diversos tipos de vajilla que utilizaron provenientes de Europa y otros países de América, que fumaban en pipas de arcillas importadas de diversas regiones de Europa y jugaban con fichas confeccionadas en fragmentos de cerámicas adaptados de viejos platos y vasijas. Aquí fue hallada la única moneda conocida del Castillo, que data de 1789, cuando Carlos IV era Rey de España, seguramente extraviada del bolsillo de alguno de los antiguos habitantes de la fortaleza.

The small vaults under the ramp were built between 1731 and 1746. They served originally as pantry, bakery and kitchen until the explosion of the fort on August 26th, 1762. During the reconstruction, between 1768 and 1778, they were used as storeroom and for trash disposal and latrine. Latrines were not used only as the fort's lavatories or restrooms, but it was also common to use them as a garbage toss zone for disposal, making them places rich in evidence of the past. Several archaeological excavations there have allowed us to rescue a great amount of archaeological evidence. The recovered artifacts, many on display in the exhibit rooms of the museum, reveal interesting aspects of the daily life of prisoners and soldiers from late eighteenth to late nineteenth century. It is through these artifacts that we know what they ate, the various utensils they used, many coming from Europe and other countries in America, the imported European pipes they used to smoke and also that they played with gaming pieces made out of ceramic fragments from old plates. The only coin that has been found in the fort also came from the latrine; it dates from 1789 when Charles IV was king of Spain; probably it fell from the pocket of one of the old inhabitants of the Castillo.

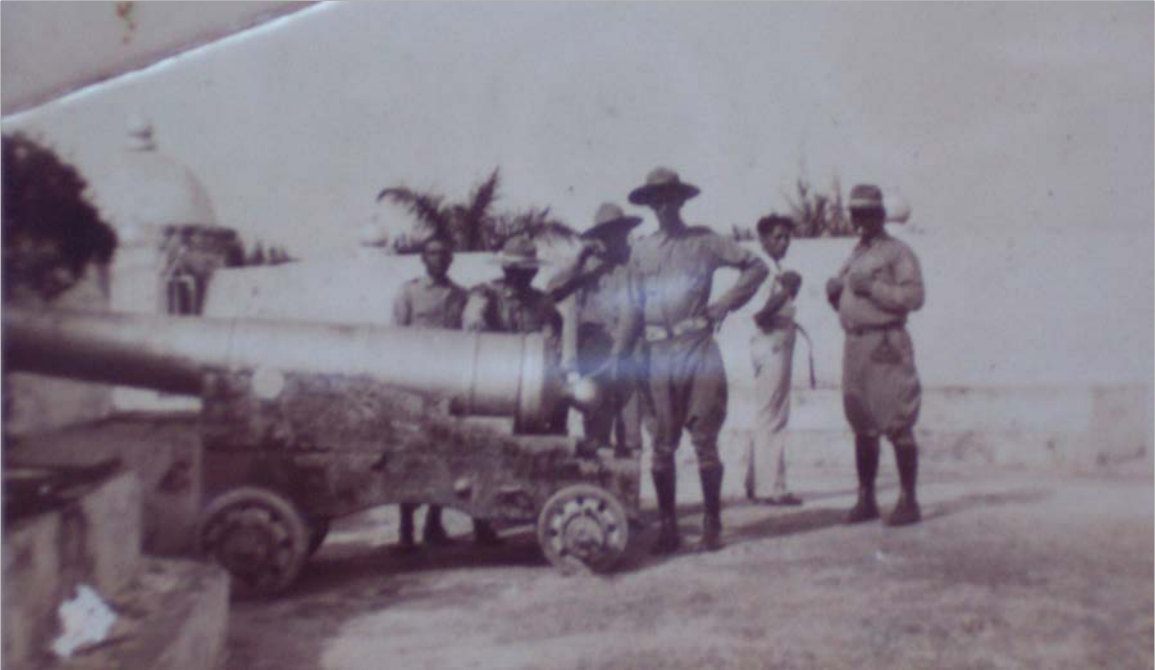
## 16 EL CAÑÓN CON CUREÑA DE MADERA

La pieza de artillería que se encuentra en el Baluarte de San Ignacio llegó a la fortaleza en algún momento de finales del siglo XVIII. Según la inscripción que se puede observar en uno de sus muñones, fue construida en 1775. El cañón, de calibre 24, con una longitud de 2.82m y un peso de 2,5 toneladas, fue originalmente concebido como armamento naval. Si se observa detenidamente, se encontrarán varios herrajes en la cureña; estos forman parte del atuendo para las amarras en los barcos. Se necesitaban hasta 12 o 14 artilleros para maniobrar estas moles de hierro. El cañón era el arma básica de cualquier barco de guerra y, por supuesto, de las fortificaciones. En el siglo XVIII los había de diferentes calibres que oscilaban desde 8 libras, los más pequeños, hasta 36 libras los más grandes. Eran de avancarga, o sea, se cargaban por la boca del cañón y se aplicaba fuego mediante una mecha para disparar. La cureña fue reemplazada de su posición original y se hizo una recreación para soportar el cañón. Un tratamiento de conservación fue aplicado a la cureña para detener el deterioro constante y así preservar la pieza de artillería más antigua con que contamos en el Castillo de San Severino. Un detalle de interés es que en la madera pueden encontrarse disímiles agujeros causados por disparos. Durante su restauración varios proyectiles de plomo fueron recuperados.

The piece of artillery located in San Ignacio's bastion arrived to the fortress sometime towards the end of the XVIII century. It was forged in 1775, according to the inscription in one of his trunnions. This 24-gauge cannon, with a length of 2.82m and a weight of 2.5 tons, was originally conceived as naval armament. A careful look will show several fittings in the carriage, these were part of the devices used to tie the piece to the ship. To maneuver this iron cannon, 12 to 14 gunners were needed. The cannon was the basic weapon of any warship and of course of fortifications. During the eighteenth century many calibers were available, ranging from 8 pounds the smallest, to 36 pounds the largest. They were muzzle loaded, and they were fired with a spark rod. The original carriage for this cannon was removed and replaced with a recreation that could support the heavy weight of the cannon. A conservation treatment was applied to the original carriage to stop constant deterioration and thus help preserve the oldest surviving piece of artillery of the Castillo de San Severino. An interesting fact is that during the restoration several lead bullets were recovered from the wooden carriage, suggesting that it was fired upon.

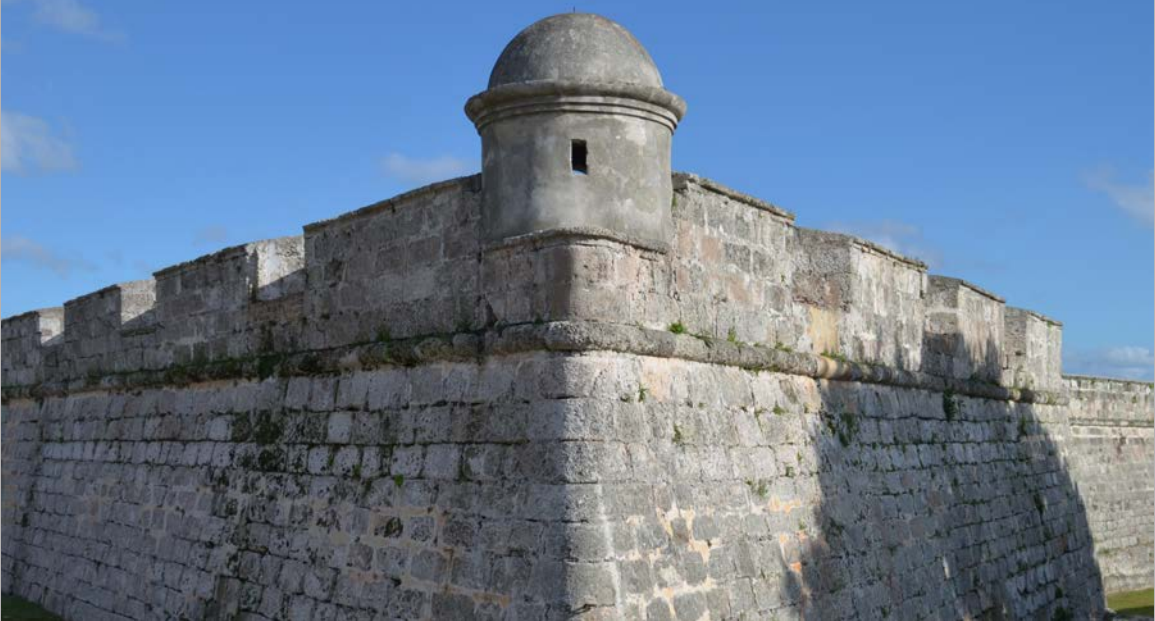
## 17 LAS GARITAS VIGÍAS DE LA BAHÍA

Las garitas son obras accesorias que se colocan habitualmente en los ángulos capitales de los baluartes. En las fortificaciones del Caribe suelen ser circulares, característica de las construcciones del siglo XVIII en adelante, aunque también son utilizadas las hexagonales. Están formadas por una cúpula, en ocasiones rematada con una piña o bola, el cornisón y el cubo o linterna que descansa sobre el cordón magistral de la fortaleza. Presentan aspilleras para el centinela poder disparar cuando sea necesario. San Severino tuvo cuatro garitas circulares con cornisón, una en cada baluarte, pero hoy solo tres sobreviven. Según los planos de perfil del ingeniero militar Antonio Conesa, en 1798 estas tenían remate, pero ninguno de ellos ha perdurado. Hacia 1808, durante las repetidas prácticas de tiro de cañón, se removió la garita del Baluarte de Santa Ana. La del Baluarte de San Antonio fue eliminada, lo que posiblemente ocurrió en 1874, cuando se instalaron allí obuses 21 del Sistema Elorza. Con ese fin se construyó un muro a barbata para la colocación de la nueva pieza de artillería y se utilizaron los mismos sillares de la garita original. Estos bloques de piedra fueron descubiertos cuando la restauración del baluarte. Un inventario de 1888 relata que una garita de madera se había instalado allí, pues ya no se contaba con la original.

Bartizans are ancillary works that are usually placed in the capital angles of the bastions. In Caribbean fortifications they are usually circular, typical of the XVIII century, although there are some hexagonal in shape. Bartizans or Garitas are formed by a dome, occasionally topped with a ball, the cornice and the lantern that rests over the cordon line. They have loopholes so the sentinel can see and shoot if necessary. San Severino had four circular bartizans but only three survive today. According to the profiles made by Military Engineer Antonio Conessa they were all crowned with balls but none of them have survived. In 1808, the bartizan located in Santa Ana's bastion was shaken during one of frequent cannon-firing practices. The one on San Antonio's bastion was eliminated, possibly around 1874, when the Elorza system, Howitzer 21cm cannons were installed. For the installation of the new artillery pieces, a barbette wall was built, using the same stone blocks of the bartizan. These stone blocks were discovered when the bastion was restored. An 1888 inventory reveals that a wooden bartizan was built there since the original had already been lost.

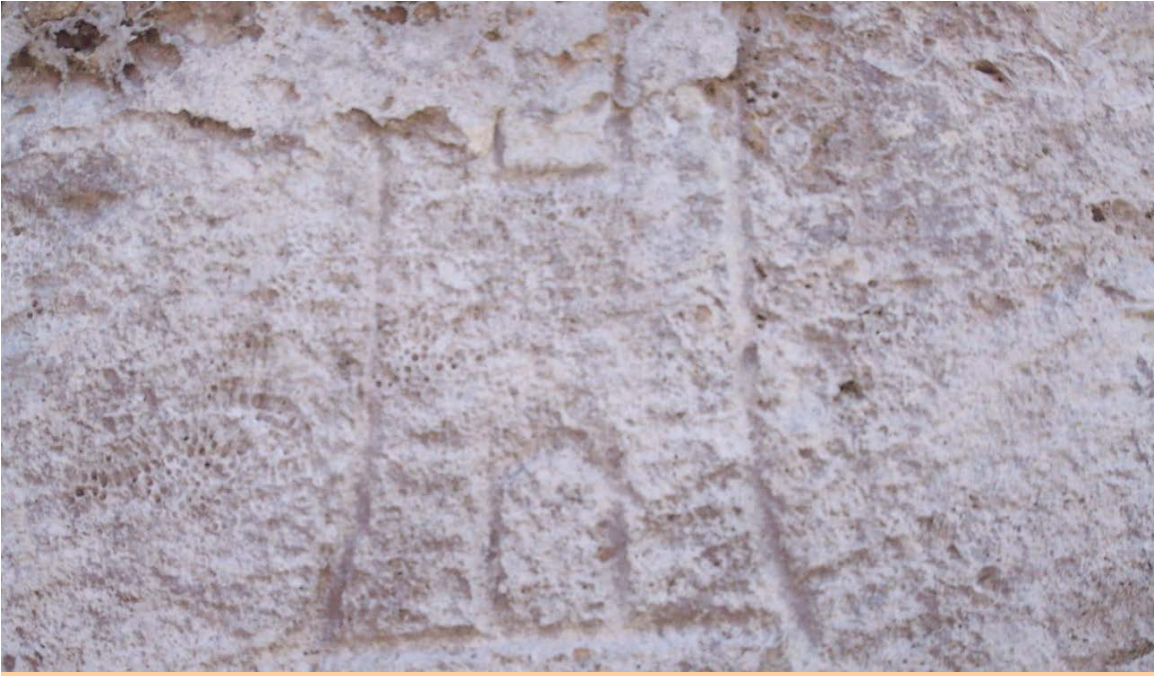
## 19 LAS MARCAS DE CANTEROS EN EL FOSO DE LA FORTALEZA

En los muros externos de la fortaleza se encuentran diferentes marcas en los sillares que se conocen como marcas de cantería o cantero. Este tipo de marcas se pueden observar desde las pirámides de Egipto hasta las grandes obras arquitectónicas de principios del siglo XIX. Se pueden clasificar según su función, en marcas de obra y marcas de identidad. Las marcas de obra u operativas se utilizaban para señalar el orden y la correcta colocación del sillar en la obra, mientras las de identidad suelen ser letras, monogramas, dibujos geométricos sencillos o complejos que por lo general se encuentran en el centro del sillar. Al parecer, los sillares de San Severino poseen marcas de identidad. Estas servían para contabilizar el trabajo realizado por cada maestro cantero o grupo de hombres a su mando y luego ser remunerados. Entre las marcas que se pueden observar, se encuentra una torre con su puerta y tronera, un barco con su mástil principal, flechas, escaleras, diferentes letras que a veces se presentan en combinación con otras. Hasta ahora se han contabilizado más de 150 marcas diferentes alrededor de la antigua fortaleza, lo que da una idea de la cantidad de canteros que trabajaron en la construcción del inmueble a lo largo del tiempo. Es interesante que las marcas sólo aparecen en el foso. En ningún sillar al interior del castillo se han logrado detectar marcas de cantería.

In the exterior walls of the fortress there are different marks in the ashlars or stone blocks that are known as mason marks. These types of marks can be seen from antiquity to the great architectural works of the early nineteenth century. They can be classified according to their function as work-related or identity marks. The work marks were used to indicate the order and correct place of an ashlar; while those of identity are usually letters, monograms, simple or complex geometric drawings usually found in the center of the stone block. Apparently those present in San Severino are identity marks. These were used to account for the work done by each master mason or group of men under his command so they could then be paid. Among the marks that can be observed, is a tower with its door and embrasure, a ship with a mast, arrows, stairs, different letters and sometimes combination of letters. So far, more than 150 different marks have been recorded around the fort, which gives us an idea of the number of masons who may have worked in the construction of the Castillo over time. It is interesting that the marks only appear on the walls around the moat, no mason marks have been found inside the fort.
